# **INDOOR AIR QUALITY ASSESSMENT**

**First District Court of Barnstable  
Route 6A  
Barnstable, Massachusetts**

Prepared by:  
Massachusetts Department of Public Health  
Bureau of Environmental Health Assessment  
Emergency Response/Indoor Air Quality Program  
November 2003

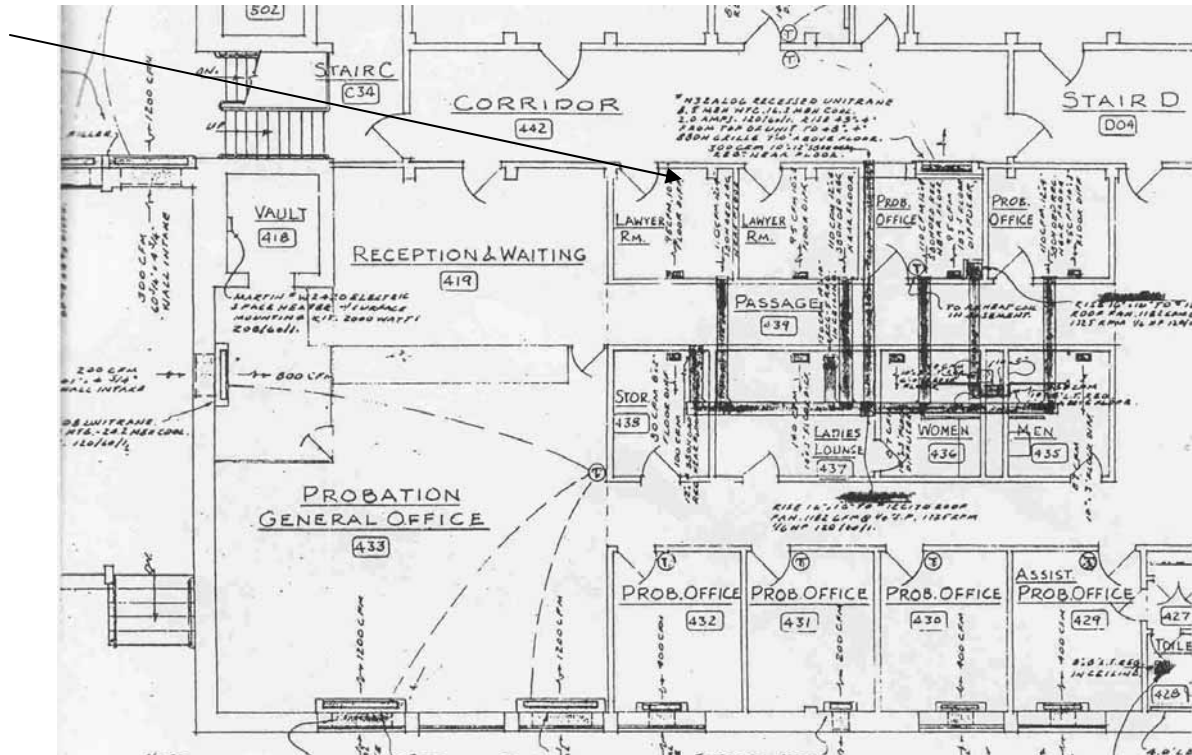
## Blueprint 1

- Exhaust ventilation: As previously noted, general exhaust ventilation does not appear to exist in the offices of this building. The lack of exhaust ventilation results in the accumulation of water vapor inside the building.
- Univent drip pans: Several univents in the upper level clerk's office were examined. While drip pans were cleaned, significant amounts of debris had accumulated in the drip pans and the condensation collectors (Picture 7).

**HVAC Configuration of Upper Level Probation Office**  
**Note No Vents Depicting Exhaust Vents Except Ladies Lounge**

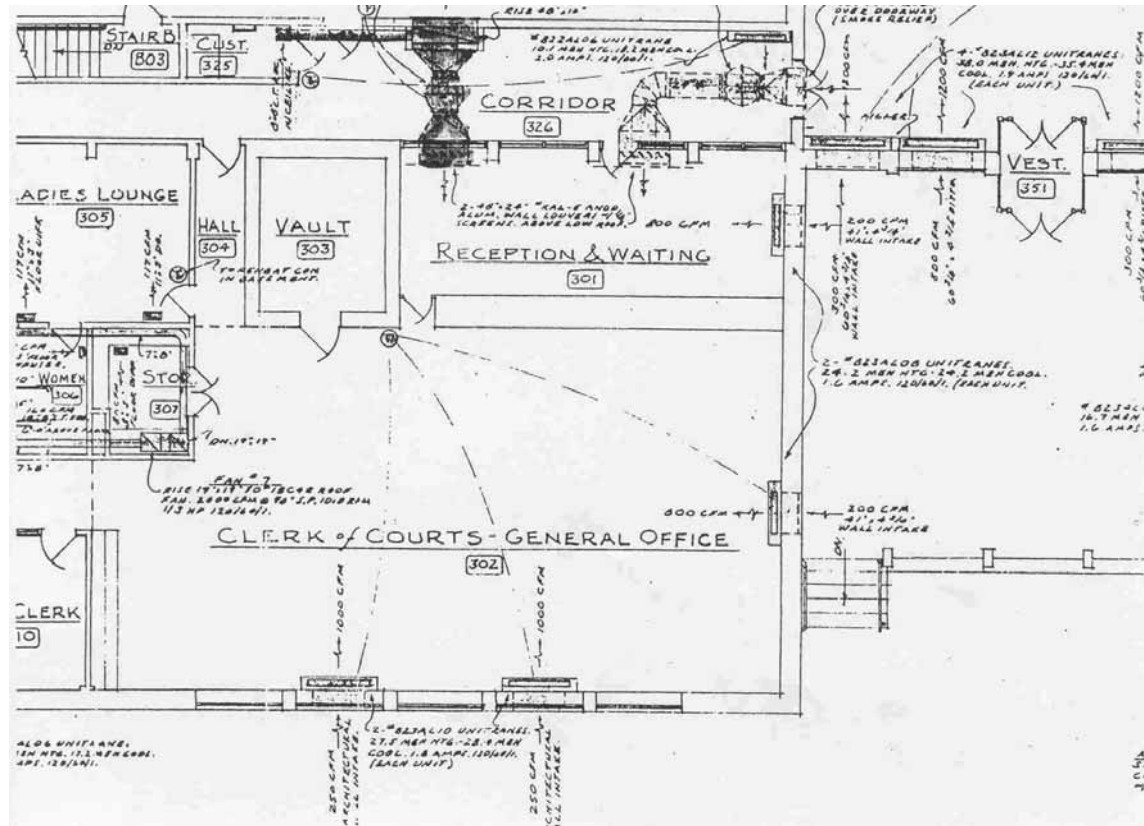
## Blueprint 2

**HVAC Configuration of Upper Level Clerk of Courts Office**  
**Note No Vents Depicting Exhaust Vents Except Ladies Lounge and Restrooms**

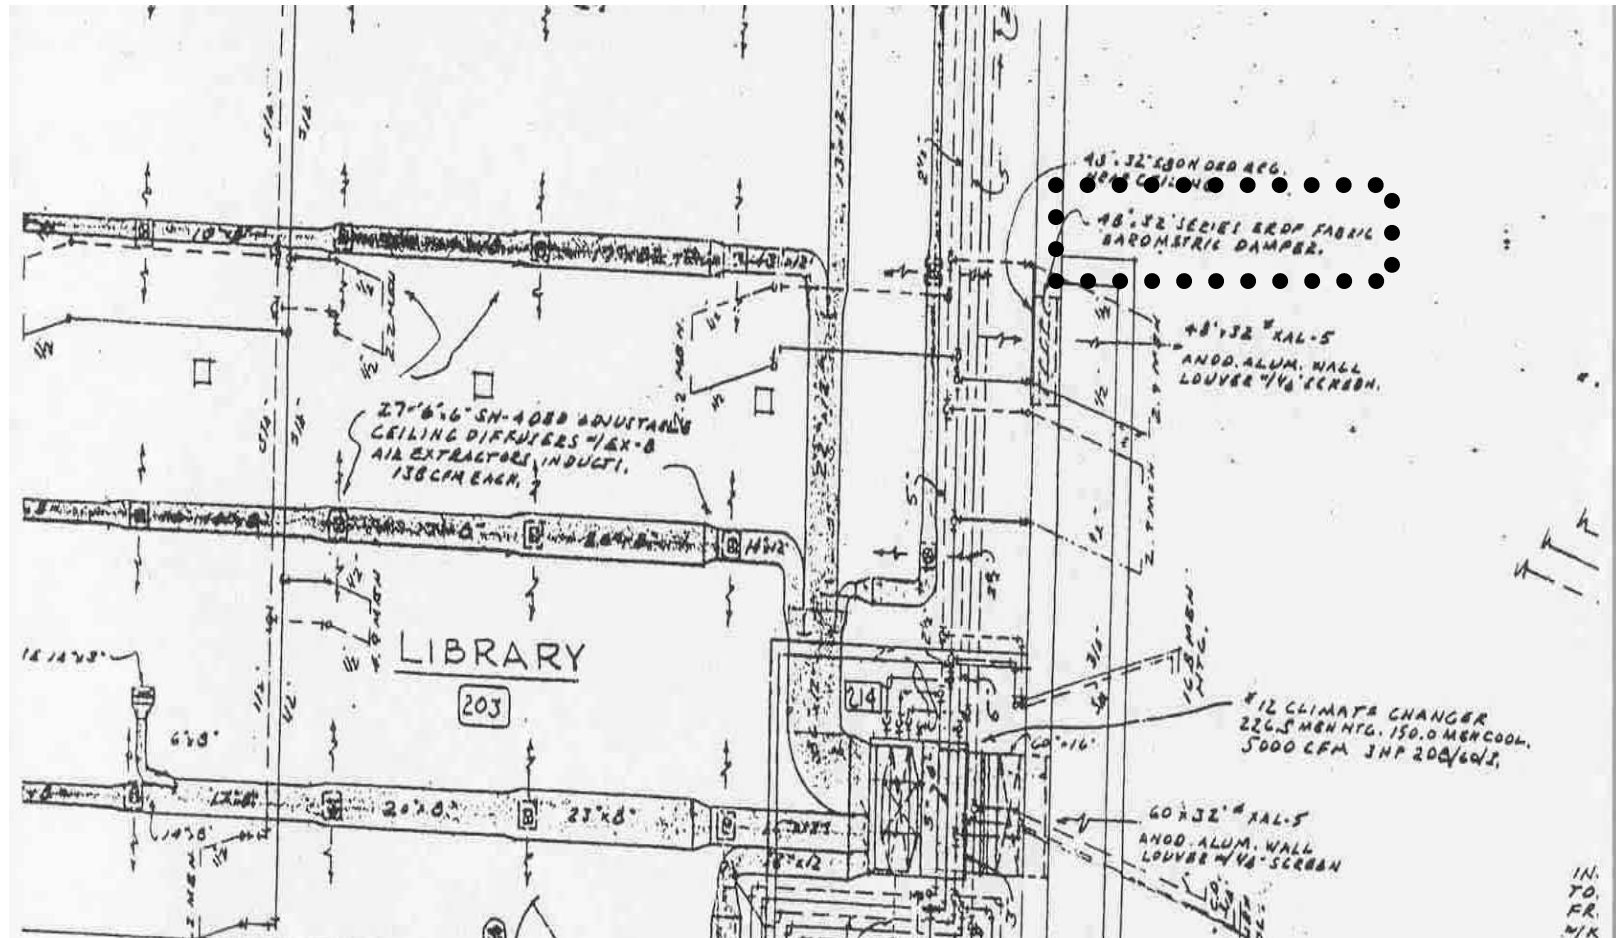
# Blueprint 3

The ventilation system for the lower level does not appear to be designed for mechanical exhaust ventilation. The blueprints indicate that fabric barometric dampers were installed to allow for the diffusion of air from ground floor areas (Blueprint 3, Picture 5). The function and problems associated with these dampers are described in detail in Appendix B. With the exception of restroom exhaust vents, the juvenile probation offices did not have barometric fabric dampers or a means for exhaust ventilation.

Fabric Barometric Damper Used for Exhaust Ventilation in Library

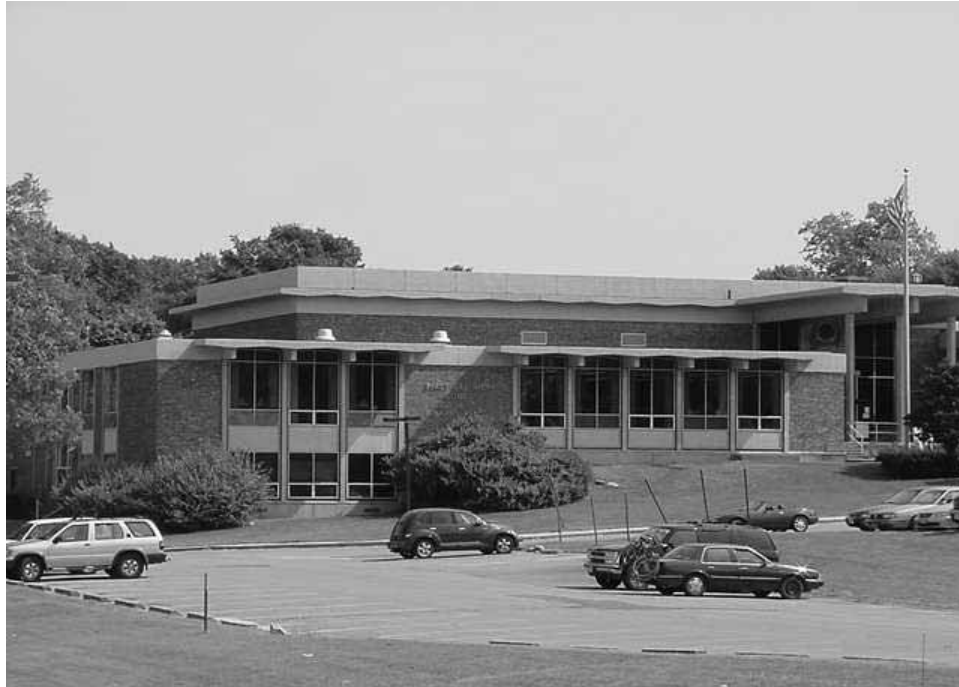
**Picture 1a**

**North Wing of Building**

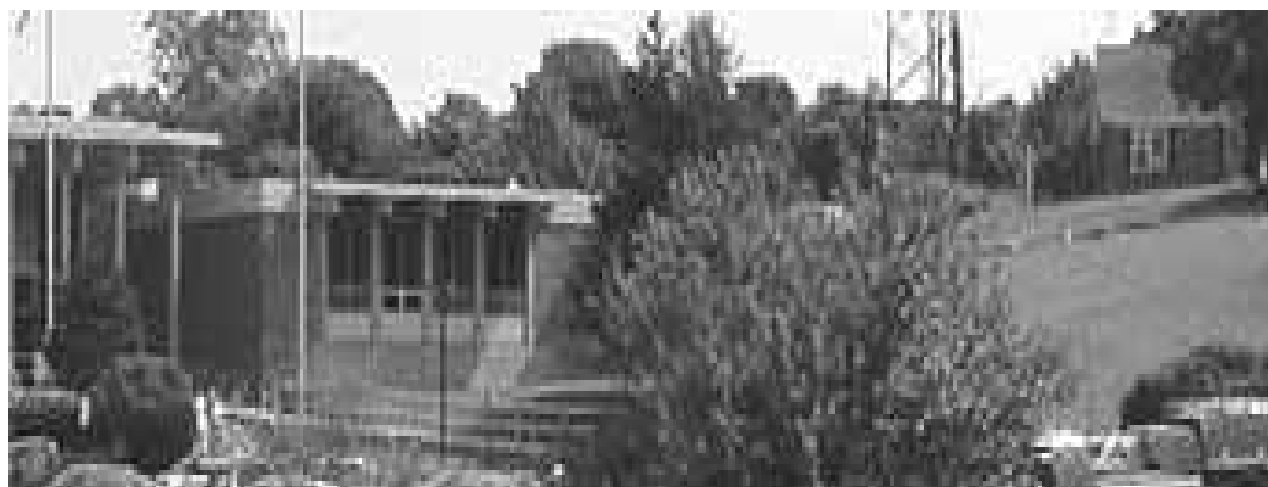
**Picture 1b**

**South Wing Built Into the Hill**

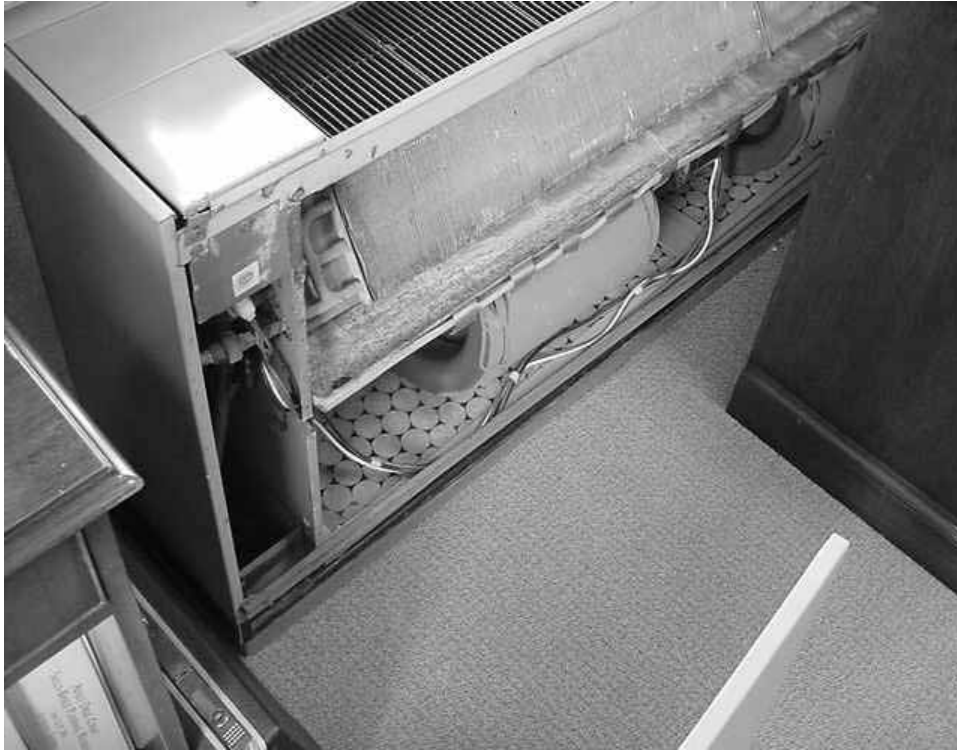
**Picture 2**

**Univents**

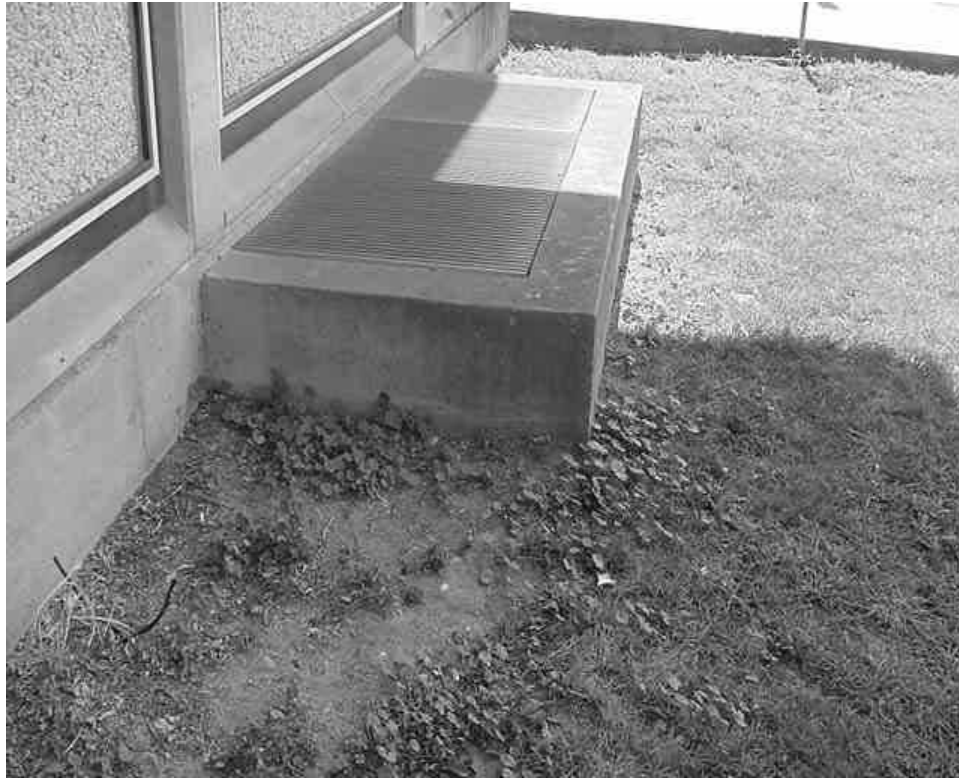
**Picture 3**

With the exception of some lower level offices, mechanical ventilation for lower level areas is provided by air handling units (AHUs). Fresh air is drawn through air intakes located in a subterranean pit (Picture 3). Ductwork connected air intakes and ceiling mounted fresh air diffusers facilitate distribution of fresh air. Air is returned to the AHU

**AHUs Draw Fresh Air through A Subterranean Pit**

- 3) Provide a three-foot space between shrubbery and fresh air intakes to prevent entrainment of pollen and microbial contaminants. Remove this vegetation after-hours to prevent entrainment of pollutants into fresh air intakes.

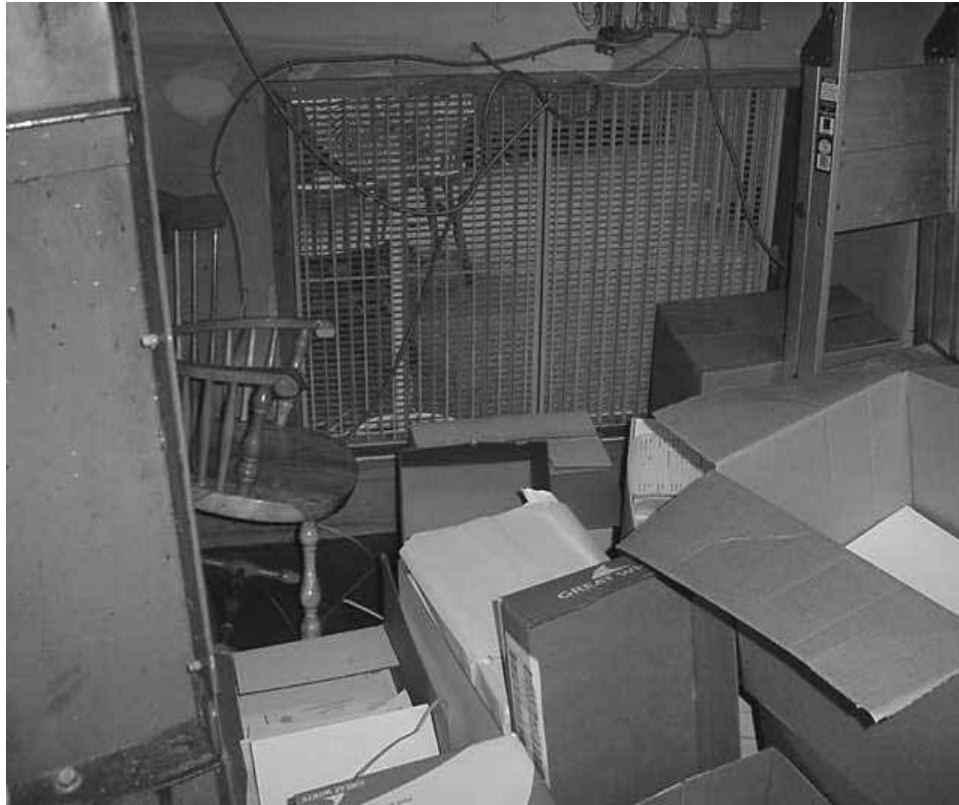
**Picture 4a**

through large grates that are located in the library, the victim protection office (Picture 4a) and the main reception area for the juvenile probation office (Picture 4b).

In the original design, it appears that return vents for the juvenile probation and victim protection offices were placed in large open areas or hallways. These open areas were later subdivided into offices through the installation of gypsum wallboard (GW) and suspended ceilings. The subdivision of these offices required a system modification that allows return air to be drawn from office areas and into hallways. To facilitate airflow, office doors are typically undercut approximately one-inch to provide a space through which air can be drawn into the hallways. At the FDCB, office doors did not appear to be undercut, thus limiting the amount of air transfer from offices to the hallway when office doors are closed. Furthermore, restrooms and break rooms have fresh air supplies connected to lower level air handling units. This configuration is unusual for restrooms, since odors and water vapor could be forced into occupied areas if the restrooms become pressurized.

**Return Air Vent for Victim Assistance Office (View Inside Mechanical Room)**

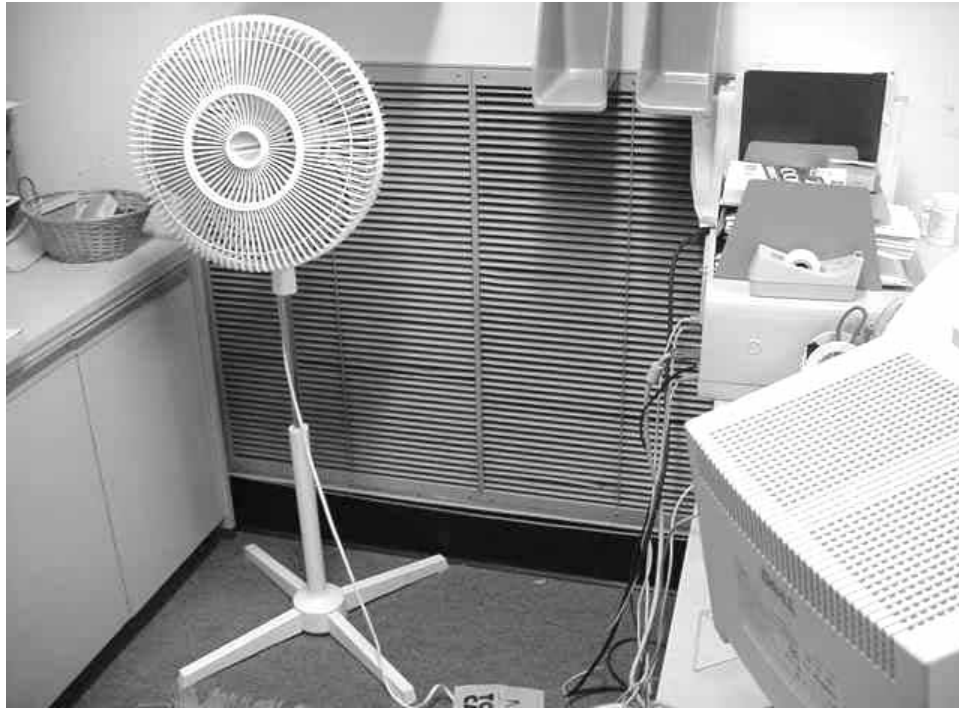
**Picture 4b**

**Return Air Vent for Juvenile Probation Offices Located in the Main Reception Area for the Juvenile Probation Office**

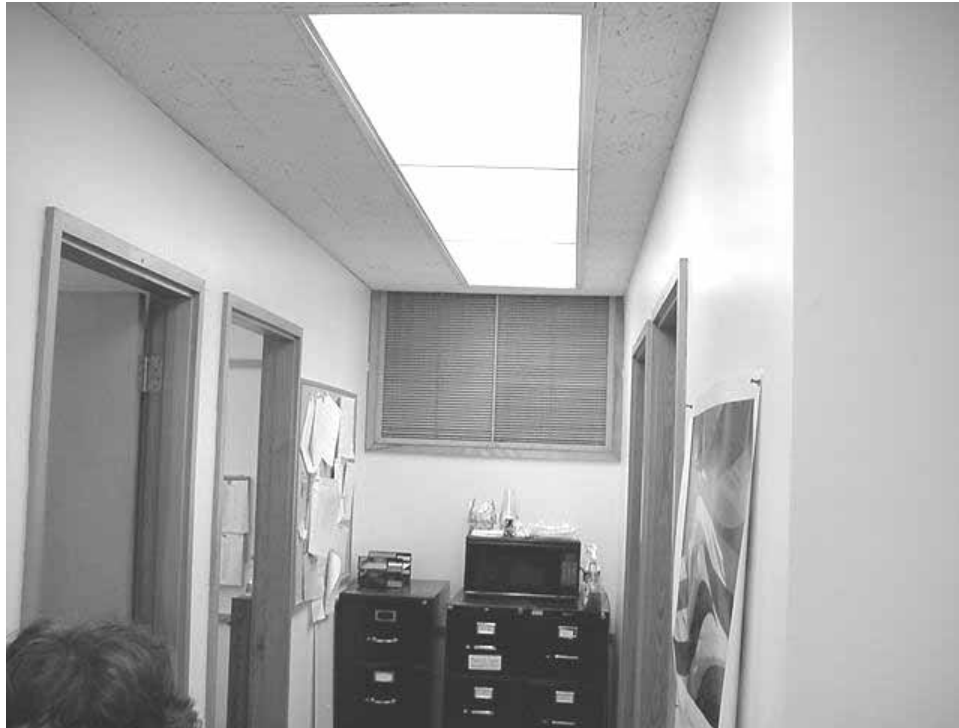
**Picture 5**

- Fabric barometric dampers: The installation of fabric barometric dampers can allow unconditioned air to enter the building. For example, the operation of the AHU in the victim assistance office likely draws substantial moisture in to the area through the fabric barometric vent. Moisture can then be distributed to upper level areas by the ventilation system. Please note that as a result of previous BEHA recommendations, a mechanical exhaust fan was installed in the barometric vent within the library. The installation of this fan has prevented water penetration into the library. Library staff did not report any additional problems with mold colonization on the book collection, even during the hot, humid weather of August 2003.

**Fabric Barometric Dampers in the Victim Assistance Office**

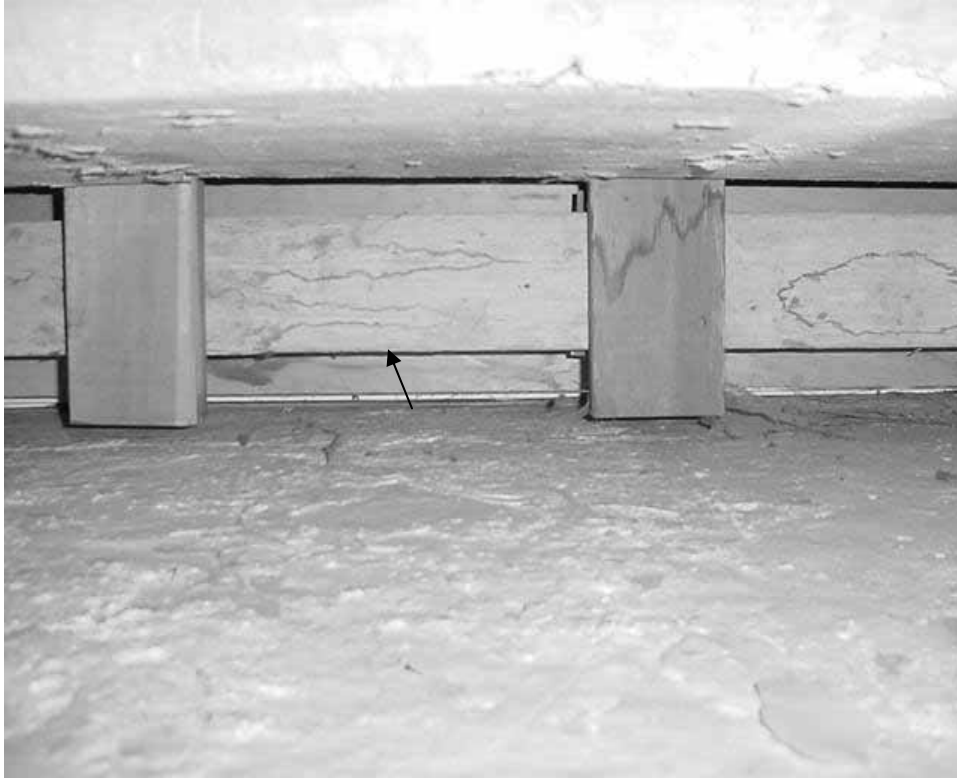
**Picture 6**

- Window system: Outdoor light could be seen from the ceiling tile system above the juvenile session courtroom, in a section without ductwork (Picture 6). This indicates that breaches may exist in the window systems of the building. These breaches allow moist air to enter into the ceiling plenum.

**Light Visible through Spaces in the Window System, (Note Water Stains Indicating Moisture Penetration)**

- 1) Repair the building's window frame system by sealing breaches and spaces.
- 2) Install univent fresh air intakes in manner that prevents penetration of outdoor air into the ground floor ceiling plenum.
- 3) Examine the feasibility of installing mechanical exhaust ventilation in office areas on the upper and lower building levels.
- 4) Install return vents in the ceiling plenum for lower level offices.
- 5) Consider removing carpeting from lower level offices.

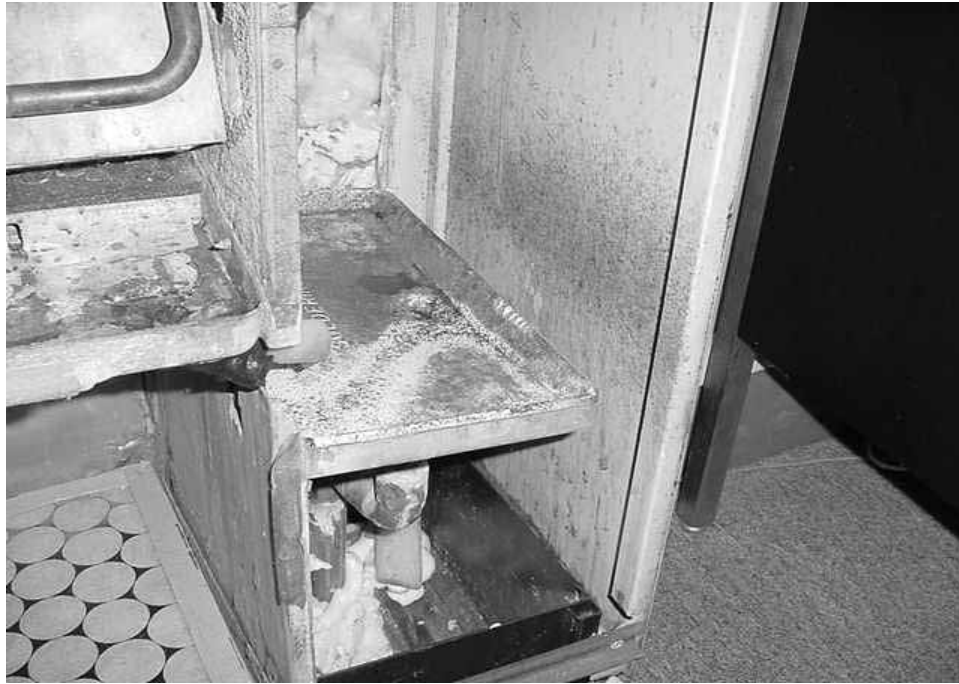
**Picture 7**

**Debris Accumulation in the Condensation Drain Collector**

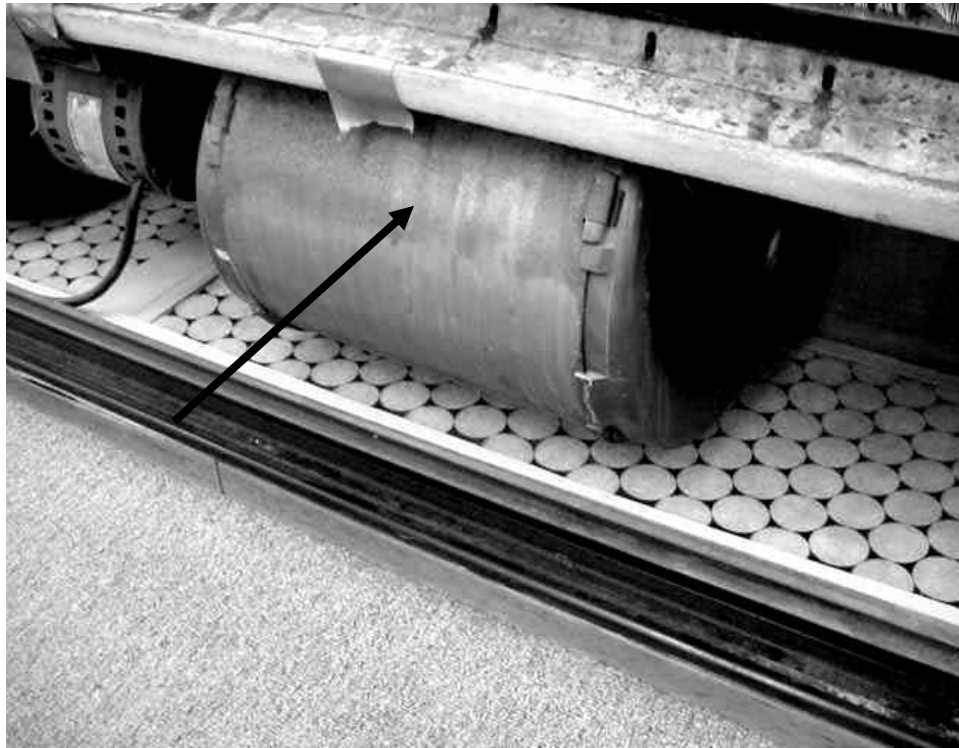
**Picture 8**

Furthermore, drip pan insulation in examined units was not replaced or repaired, as previously recommended (Picture 8). Without intact insulation, condensation can accumulate on metal univent components and cause the univent cabinet and surrounding carpet to become wet.

**Damaged Insulation of Univent Drip Pans (Note Corrosion on Fan Casing below Drip Pan, Which Is Likely From Condensation Exposure)**
